DEPARTMENT OF TRANSPORTATION**DIVISION OF ENGINEERING SERVICES**

Quality Assurance and Source Inspection

Contract #: 04-0120F4Cty: SF/ALA Rte: 80 PM: 13.2/13.9File #: 1.28**WELDING INSPECTION REPORT****Resident Engineer:** Casey, William**Address:** 333 Burma Road**City:** Oakland, CA 94607**Report No:** WIR-027152**Date Inspected:** 07-Feb-2012**Project Name:** SAS Superstructure**OSM Arrival Time:** 700**Prime Contractor:** American Bridge/Fluor Enterprises, a JV**OSM Departure Time:** 1730**Contractor:** American Bridge/Fluor Enterprises, a JV**Location:** Job Site**CWI Name:** Steve Jensen**CWI Present:** Yes No**Inspected CWI report:** Yes No N/A**Rod Oven in Use:** Yes No N/A**Electrode to specification:** Yes No N/A**Weld Procedures Followed:** Yes No N/A**Qualified Welders:** Yes No N/A**Verified Joint Fit-up:** Yes No N/A**Approved Drawings:** Yes No N/A**Approved WPS:** Yes No N/A**Delayed / Cancelled:** Yes No N/A**Bridge No:** 34-0006**Component:** SAS OBG**Summary of Items Observed:**

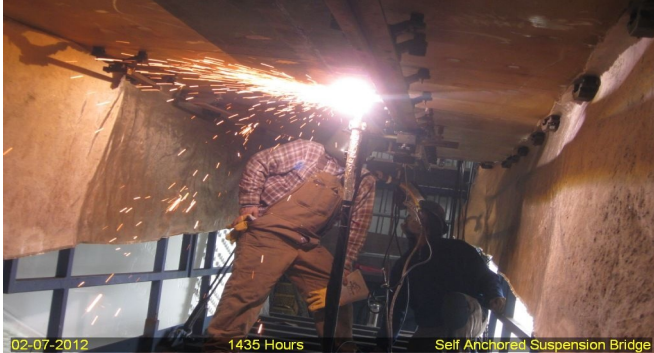
At OBG 13W/14W-E side plate outside, QA randomly observed ABF personnel Rory Hogan perform plasma arc gouging on the backing bar removal of the splice butt joint. The personnel were using an Esab plasma arc gouging machine that has the nozzle holder attached to a Bug-o track. Gouging of the backing bar was not completed today

At OBG 13W/14W-E side plate outside, ABF welder Rory Hogan was noted performing back gouging on the removal of backing bar. The welder was using plasma arc gouging during the removal of the backing bar.

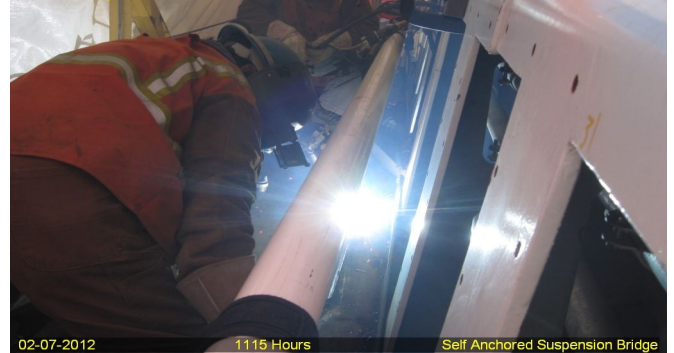
At OBG 8W PP61.5 W2 deck access hole infill plate to top deck plate outside, QA randomly observed ABF/JV qualified welder Wai Kitlai continuing to perform CJP groove welding fill pass then cover pass on the straight portion of the butt joint. The welder was observed perform automatic welding in the 1G (flat) position utilizing a Bug-o track mounted dual shield Flux Cored Arc Welding (FCAW-G) with E71T-1M, 1/16" diameter wire electrode and implementing Caltrans approved Welding Procedure Specification (WPS) ABF-WPS-D15-3030-1. The joint being welded had a single V-groove butt joint that has been root welded without backing bar. The splice joint was preheated to greater than 150 degrees Fahrenheit using propane gas torch prior welding. During welding, ABF Quality Control (QC) Steve Jensen was noted monitoring the welding parameters of the welder. Measured welding parameters were 254 amperes, 23.5 volts and travel speed of 340mm per minute with calculated heat input of 1.05Kjoules per mm. During the shift, cover pass welding on straight portion of the butt joint was completed and the welder has moved to the other deck access hole 8W PP70.5 W2 and performed FCAW welding fill pass on west side radius portion of the butt joint. At the end of the shift, fill pass welding was still continuing and should remain tomorrow.

At OBG 8W PP61.5 W2 deck access hole infill plate to top deck plate outside, ABF welder Wai Kitlai was observed performing 1G Flux Cored Arc Welding (FCAW-G) welding fill pass to cover pass on straight portion of the butt joint.
